OAKFORD LAKE DAM
NJ 00544

PHASE 1 INSPECTION REPORT
NATIONAL DAM SAFETY PROGRAM

Philadelphia District
Corps of Engineers
Philadelphia, Pennsylvania

January, 1979

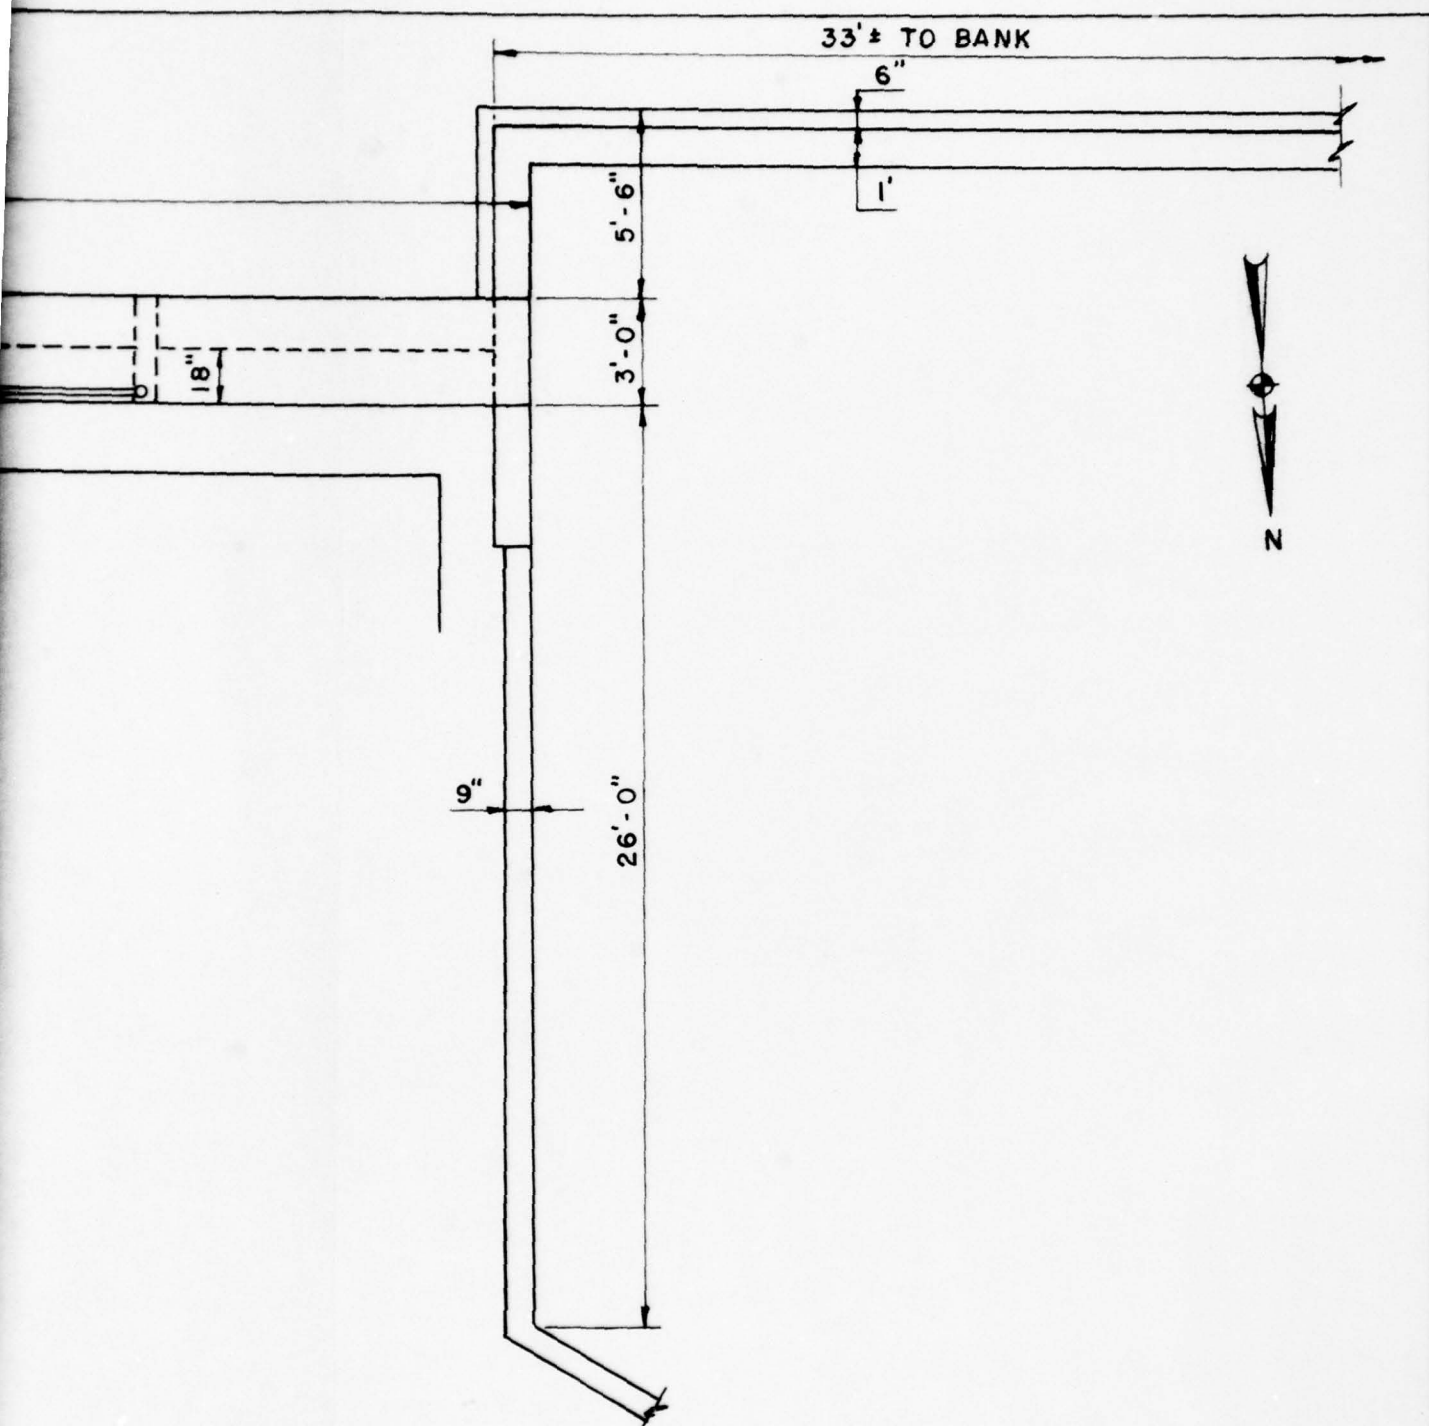
HARRIS-ECI ASSOCIATES		
OAKFORD LAKE DAM		DWG. NO. 2
FIELD INSPECTION SKETCH

FIELD INDICATES
PRESSION IN CHANNEL

K IN SILL
ING
